MÉGANE II RS

59A ISOFIX SEAT MOUNTING
OTS: 0AYC MARK: L2

TECHNICAL INFORMATION

FITTING OF MOUNTING RINGS

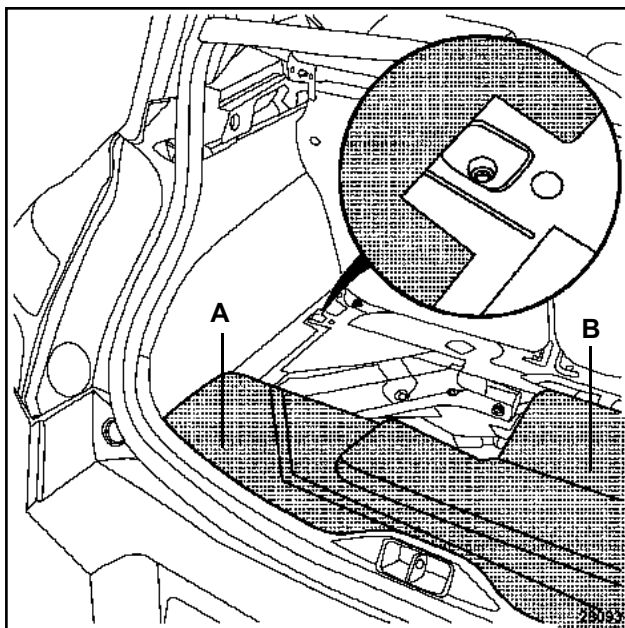
A – Luggage compartment carpet

B – Emergency spare wheel storage compartment carpet

- Lift up:
 - the rear section of the luggage compartment carpet (A),
 - the emergency spare wheel storage compartment carpet (B).
- Fold back:
 - the rear section of the luggage compartment carpet (A),
 - the emergency spare wheel storage compartment carpet (B).

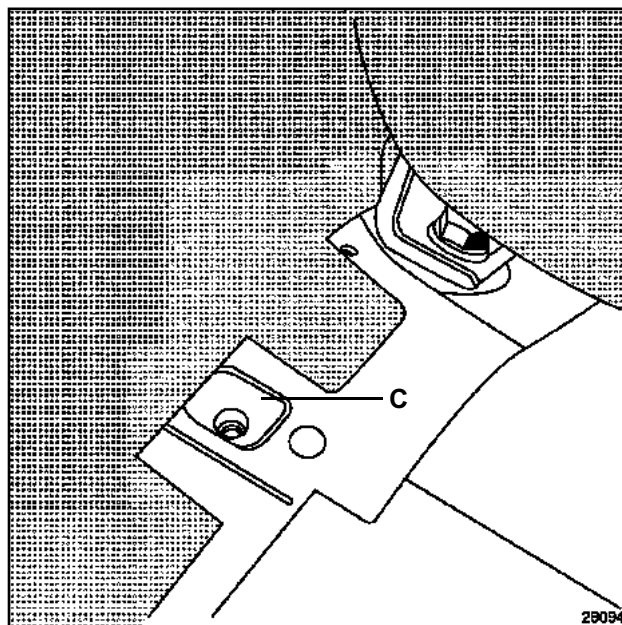
C – Mounting ring positioning area

- Fit the right-hand and left-hand side mounting rings in area (C).

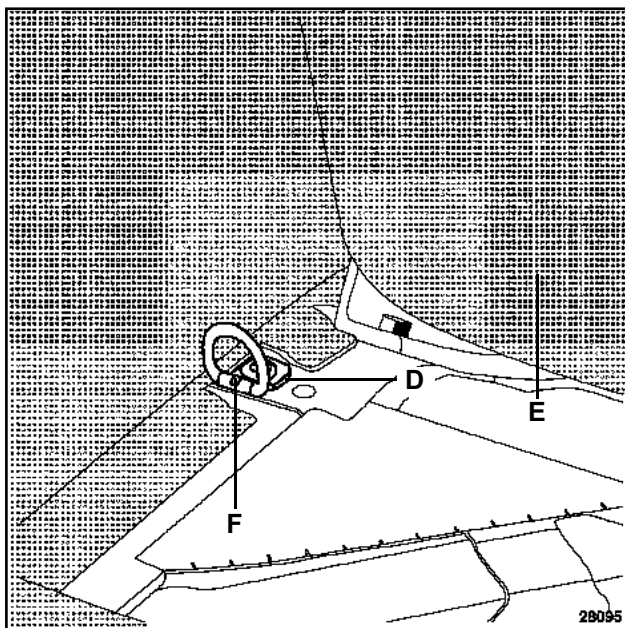
The mounting (D) must be located near the rear bench seat backrest (E), and the removable ring (F) near the rear of the luggage compartment.

- D – Mounting
E – Rear bench seat backrest
F – Removable ring

- Fit the right-hand and left-hand mounting rings.
- **Torque tighten the bolts to 21N.m.**
- Unfold the carpets.
- Pull the mounting rings through the openings in the luggage compartment carpet.

It is **ESSENTIAL** to observe the 21 N.m tightening torque of the right-hand and left-hand ring bolts specified in the Technical Note.

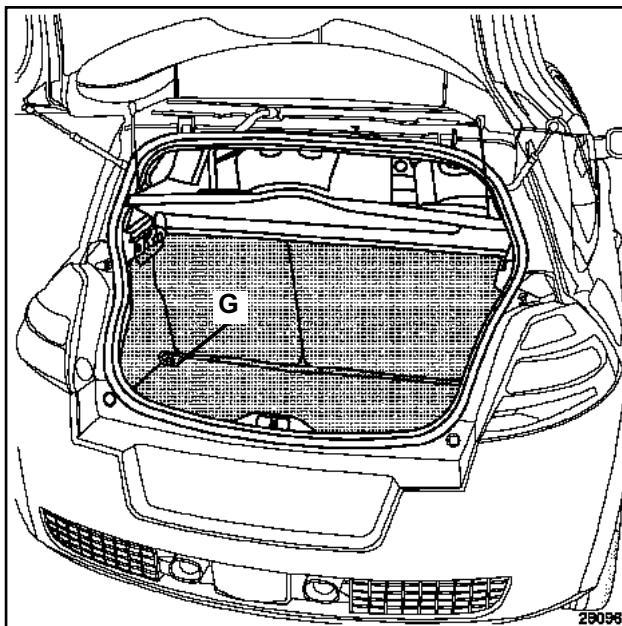
- G – Openings in the carpet
